TECHNICAL BULLETIN
TOOWOOMBA IRON HUB- DISC ROTOR
REPLACEMENT
LIT NO: 97117-254
DATE: August 2015 REVISION: A

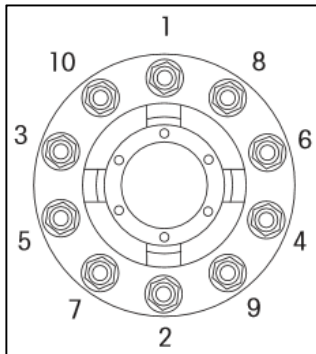
7. Connection of hub to rotor.
 - a. Torque the hub to rotor in star sequence as follows with an initial torque of **100 Nm (70 ft-lb)** and then final torque of **300 Nm (220 ft-lb)**.
