No: 97117-202
Subject: QUIK ALIGN FASTENER REPLACEMENT
Date: AUGUST - 2009 Revision: A

INTRODUCTION

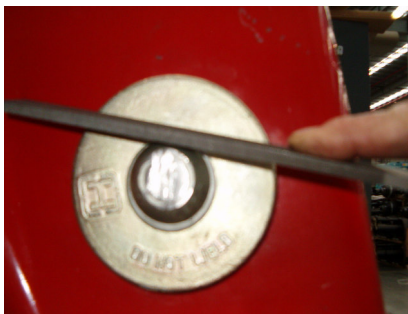
Figure Two - Initial Filed Section Figure Three - Additional Filed Section Figure Four - Vise Grip Pliers

- 5. Remove the shear head bolt in accordance with the following steps:
 - a. Spray a liberal amount of anti seize onto the inboard hex nut.
 - b. With a 2nd Cut Millsaw file, file a flat on the dome head bolt - Figure Two.
 - c. File an additional flat section on the opposing side - Figure Three.
 - d. Attach Vise Grip style pliers to the filed flat section of the dome head bolt – Figure Four.
 - e. Loosen, remove and discard the dome head bolt / hex head nut.

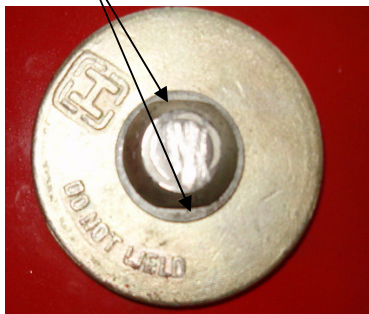
Opposing Filed Flats

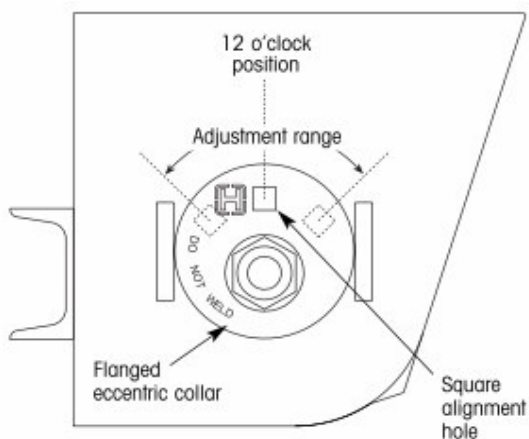
Figure Five - Eccentric collar orientation details

- c. Inspect the orientation of the square alignment hole in the flanged collar (Figure Five). The commencement point should be with the alignment square hole at the 12 o'clock position, which is the middle of the adjustment range. A 1/2 inch breaker bar can be used in the square flanged eccentric collar to enable the collar to be rotated to the 12 o'clock position.
- d. Gradually tighten the QUIK-ALIGN Pivot Bolt until the flat hardened washers just stop rotating. Any further tightening of the pivot bolt or **rotation** of the eccentric collar (to effect adjustment) must be accompanied by tapping of the concentric collar (inboard side of frame hanger) with a hammer.

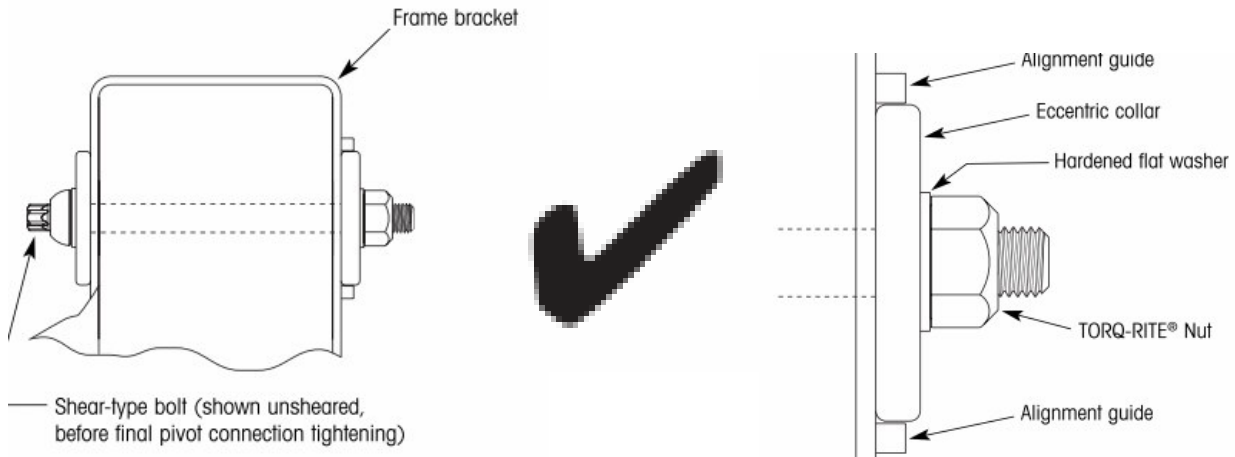
Figure Six – Correctly Installed QUIK-ALIGN Pivot Connection prior to shear.

Tapping allows the flanged concentric and eccentric collars to move and adjust in unison and enable correct seating - **Figure Six**. If the collars do not move and adjust in unison, the concentric collar may wedge or be partially raised on the frame bracket alignment guides - **Figure 7**. This action can cause an improper pivot connection that could potentially loosen and lead to an inaccurate alignment.

- e. On completion of all wheel alignment adjustments, tighten the QUIK-ALIGN Pivot Bolt using an E20 Torx Socket (see Table One), until the Torx head shears off. This ensures proper torque of 740 N.m (550 ft-lb) plus or minus 60 N.m. To avoid damaging the shear bolts Torx head (regardless of the drive socket being used), the drive socket must fully engage the Torx head. **See Figure Eight.**
- f. Inspect the surface between the concentric – eccentric washers and the frame hanger to ensure correct seating and that there is no evidence of a wedged collar - detailed at **Figure Six.**

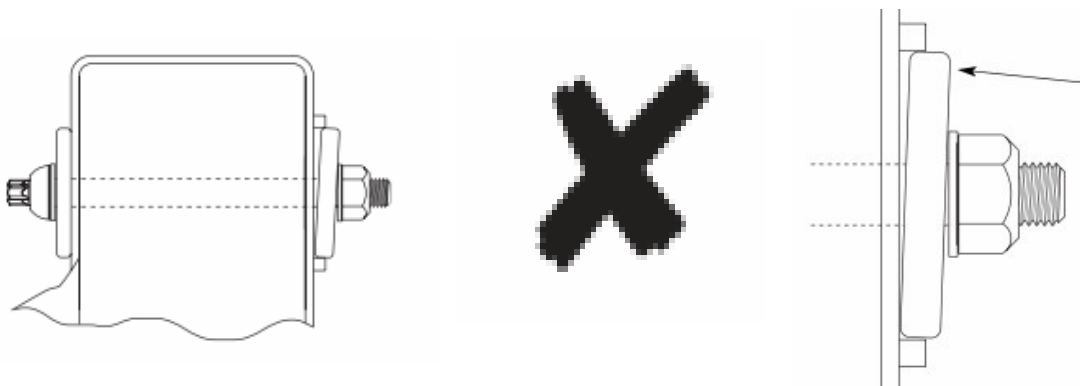
Figure Seven - Partially raised / wedged collar due incorrect tightening process.
