TRAILER SUSPENSION

TECHNICAL BULLETIN

No: 97117-177
Subject: HT 230 Lower Shock Absorber Bracket
Date: February – 2009 Revision C

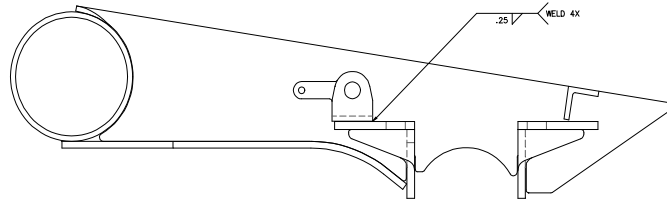
Figure 1.

Instances of a cracked weld around the trailing arm shock absorber bracket have been reported. In the event that the lower shock absorber clevis becomes detached, or a crack is detected at the connection to the trailing arm (see Figure 1), the clevis can be effectively replaced.

Kit Part number 98544-021 is available to effect the repair. The kit contains a replacement clevis, shock absorber bolt and reinforcement gusset block. Where the weld retaining the original clevis has cracked, or the clevis has become detached, grind off the remaining weld. It is paramount that cracks or damage to the trailer arm plate are ground, welded and the area is smooth and flat prior to the new clevis being fitted.

In accordance with Welding Instruction Drawing 49441-249 assemble as follows:

- a. Position the reinforcement gusset Part No. 98870-004 with the chamfered edge toward the trailing arm.
- b. Apply a weld around the block in one continuous bead commencing and terminating ten millimetres from the existing beam weld.
- c. Bolt the clevis to the gusset block with the bolt provided. Weld the clevis to the gusset block in one continuous bead.
- d. Clean and paint the repaired area.
