TECHNICAL BULLETIN

HN402 TRUCK SUSPENSION HN402 IMPROVEMENT

No: TRUCK AUS-008

Subject: *Product Update*

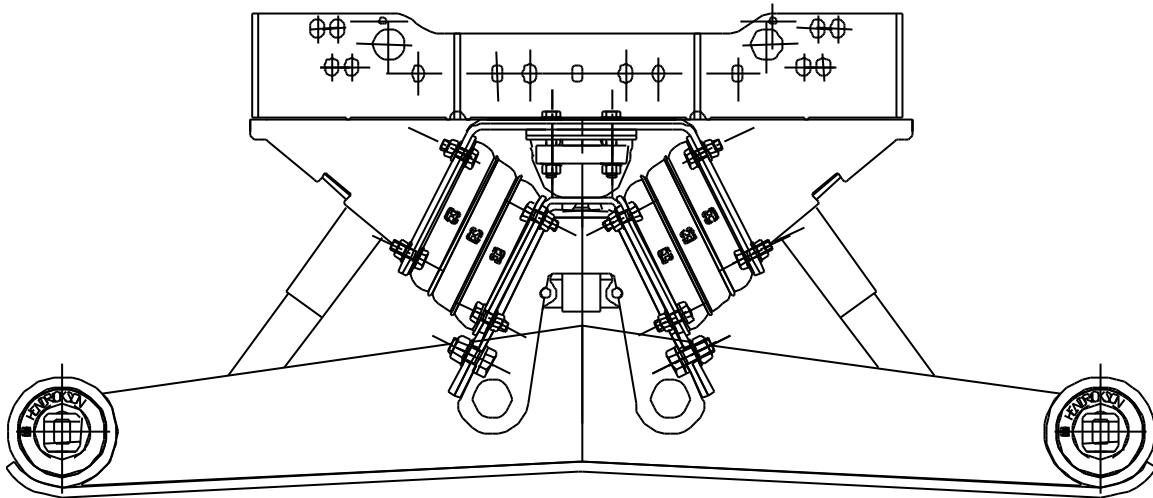
The new Beam Assembly including Vee plate is a direct replacement for the previous beam assembly. Beam assembly 98743-001 is replaced by 98969-004. The main feature of this change is that the bolster springs are bolted to a Vee plate, which is then bolted to the beam making for easier disassembly and servicing. See the above diagram.

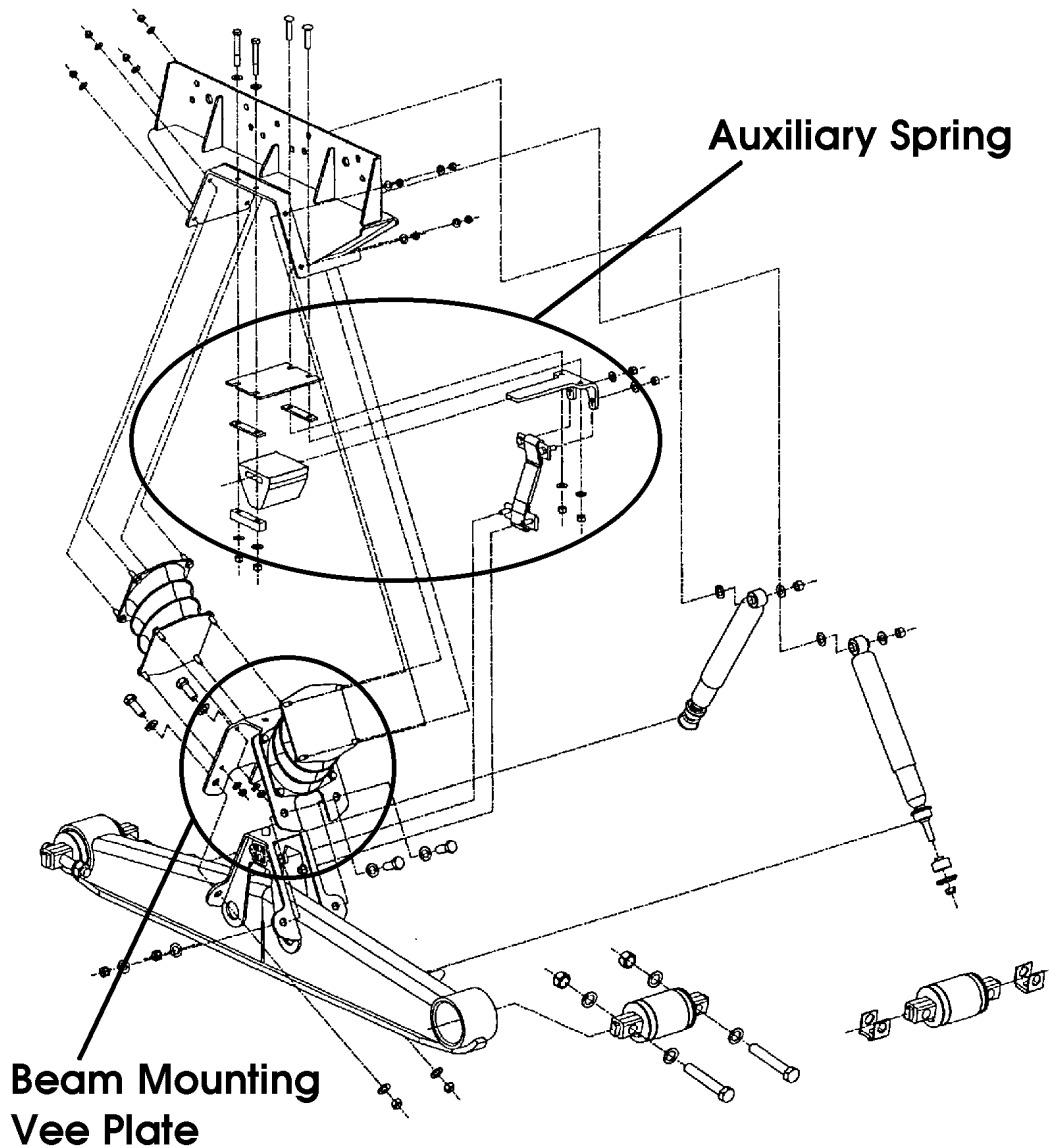
The Auxiliary Spring is a more noticeable change with a new look and a more durable material with simpler construction.

This new auxiliary spring provides a greater resistance to taking a "set" so will maintain its performance without requiring adjustment for longer. When adjustment is required, the new mounting method simplifies this process.
