No: 97117-157
Subject: Top Pad Bolt Maintenance
Date: March 2007 Revision: D

Primaax Longitudinal Torque Rod to Top Pad Bolt Maintenance

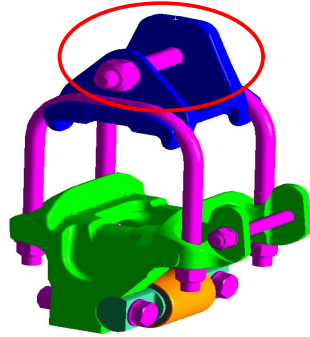
Failure to ensure that the top pad bolt tension is maintained may cause the top pad and through bush holes to elongate. Once wear occurs, it will not be possible to maintain the top pad bolt torque settings as they will continually come loose during operation.

The initial torque is set by the truck OEM during assembly. The torque setting for the 7/8" – 14 UNF bolt must be maintained at **525-575ft/lb (712 – 780Nm)**. In the initial shake down, the suspension will move and adjust to its normal operating position and this movement may cause the bolt to lose tension slightly.

It is recommended that the top pad bolt torque is checked at pre-delivery, first service and must be checked as per the maintenance schedule. This will ensure the top bolt remains at the correct tension at all times.

1. Fit the M24 bolt, nut & washers as needed. Refer to the parts list on page 3.
2. Using an angle gauge, measure each torque rod angle from the top pad to the hanger prior to disassembly and note the angles. *(For pre-assembly on bench).*

3. Remove the torque rod from the top pad (fit a new through bush if required).
4. Replace the existing 7/8 top pad bolt with the M24 bolt. The M24 bolt should fit straight into the top pad bolt holes. If the bolt does not fit, it will be necessary to ream out the top pad bolt holes to accept the M24 bolt.
Note: do not use a drill to increase the hole diameter! If the M24 bolt is not a snug fit in the top pad bolt holes, then a replacement top pad must be fitted.

5. Assemble the new top pad/torque rod on a bench with the M24 bolt and washers each side. Lightly tighten the M24 bolt and use the angle gauge to set the correct angle of the torque rod.

6. When the torque rod angles are set to each measurement as taken prior to removal from the vehicle, tension the M24 bolt to **700-750ft/lb**.
7. Install the top pad/rod and tighten the top pad U bolts as per P14/P38 of the Primaax service manual. **Note:** There should be minimal movement of the rod required to fit the straddle through bolts to the hanger (any tension on the bushes preloads the rubber, which could cause early failure).

8. Re-check the torque setting after 1500kms.
9. Follow standard maintenance schedules.
