TECHNICAL BULLETIN

TOOWOOMBA IRON HUB – DISC ROTOR REPLACEMENT

LIT NO: 97117-254

DATE: January 2020 REVISION: C

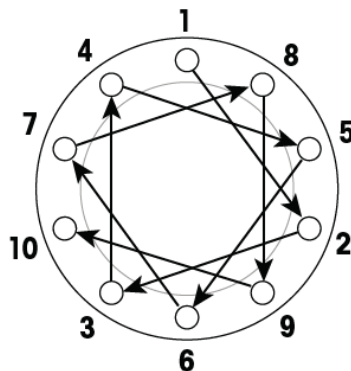
Torque the hub to rotor in star sequence following the sequence shown in the following diagram.

| Stage | Application | Torque | |
| Initial Torque | All | 100 Nm | 70 ft-lb |
| Final Torque | Silver Zinc Coated Washer and/or Bolt | 270 Nm | 200 ft-lb |
| | Black Phosphate Oil Coated Bolt and Washer | 300 Nm | 220 ft-lb |
