No: 97117-177
Subject: HT 230 Lower Shock Absorber Bracket
Date: February – 2009 Revision D

| | | WELDING INST. FOR HT230 SHOCK CLEVIS | | 49441-249 | |

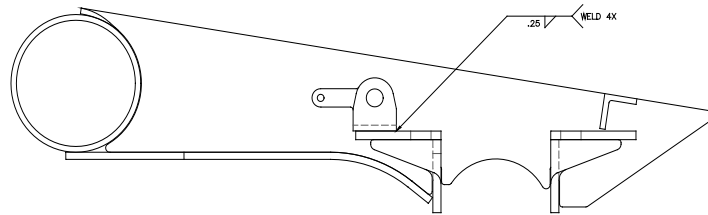
Figure 1.

Instances of a cracked weld around the trailing arm shock absorber bracket have been reported. The clevis can be effectively replaced if the lower shock absorber clevis becomes detached or a crack is detected at the connection to the trailing arm (see Figure 1).

Kit Part number 98544-021 is available to complete the repair. The kit contains a replacement clevis, shock absorber bolt and reinforcement gusset block. Where the weld retaining the original clevis has cracked, or the clevis has become detached, grind off the remaining weld. It is paramount that cracks or damage to the trailer arm plate are ground, welded and the area is smooth and flat prior to the new clevis being fitted.

- Position the reinforcement gusset, Part No. 98870-004, with the chamfered edge toward the trailing arm.
- Apply a weld around the block in one continuous bead commencing and terminating ten millimetres from the existing beam weld.
- Bolt the clevis to the gusset block with the bolt provided. Weld the clevis to the gusset block in one continuous bead.
- Clean and paint the repaired area.
