H TECHNICAL BULLETIN

HN SERIES TRUCK SUSPENSION

No: 97117-118

Subject: *Bolster Spring Inspections*

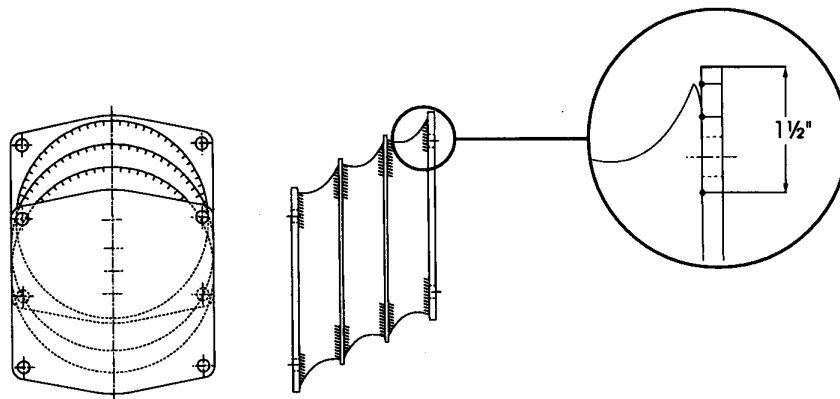
The most probable areas of damage are shown in the picture above as "//////"

Bonding defects showing separation of the rubber from the bonded metal surface to a depth of approximately 1½" is acceptable. See picture above.

If the depth is more than 1½" the bolster spring should be replaced.
