# TECHNICAL BULLETIN

## TRAILER AIR SUSPENSIONS

**No:** 97117-120  
**Subject:** AANT 230 Hanger Repair Kit  
**Date:** May 2004 **Revision:** C

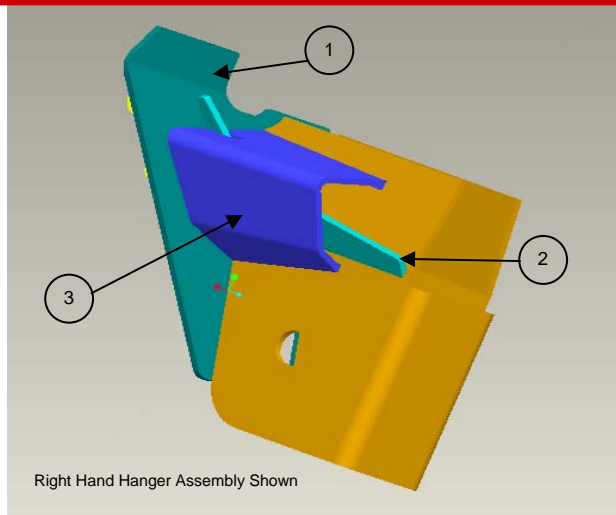
It has been reported that in some instances the top clevis assembly for the shock absorber has broken away from the hanger wing.

There are two (2) parts in these kits, A gusset (Fig.3) and a front plate (Fig.1).

Note: Boomerang (Fig.2) as shown is no longer required.

In order to improve repair times, the quality of the repair and reduce customer downtime, Hendrickson Asia Pacific wish to advise Authorised Repairers that a Repair Kit has been released to facilitate this.

There are two (2) kits repair kits that are available. One for the Left Hand Hangers (98544-042) and one for the Right Hand Hangers (98544-043).

The Gusset as shown (Fig. 3) is available as a separate item if required. Part No 98870-033 for the left and 98870-034 for the right.
