TECHNICAL PROCEDURE

TRI-FUNCTIONAL® BUSHINGS

SUBJECT: Bushing Tube Spacer
Inspection / Replacement Procedure

LIT NO: L750

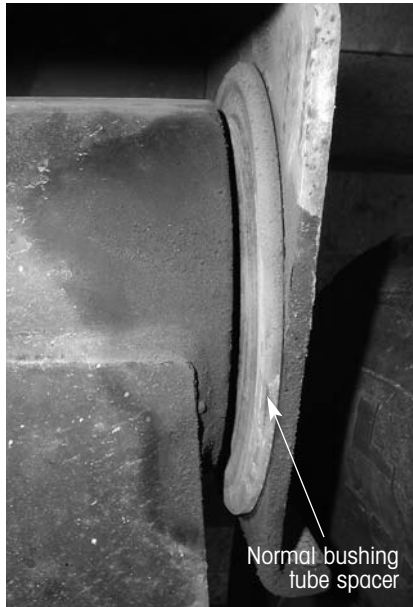
NORMAL

Normal bushing tube spacer

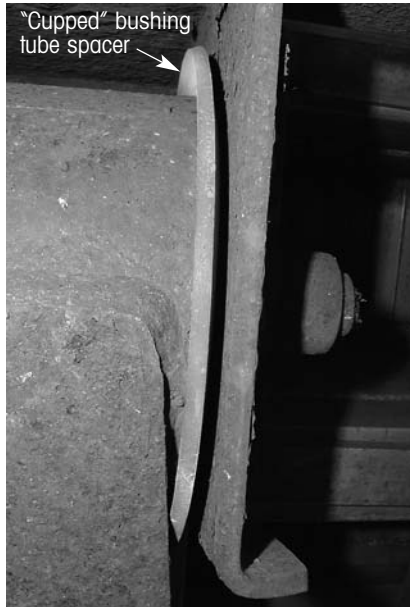
"CUPPED" — ALSO NORMAL

An example of a "cupped" bushing tube spacer. Friction-generated heat causes the spacer to "form" or "cup" around the bushing and bushing tube. This is normal as long as the bushing tube spacer remains intact and does not become cut or worn-through.

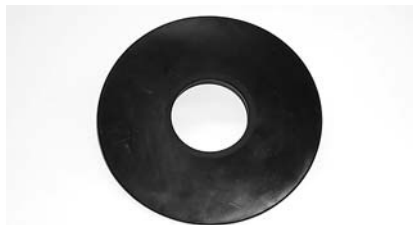
"WORN-THROUGH" — ABNORMAL

Examples of "worn-through" bushing tube spacers. The spacer on the right is an example of extreme wear. Its circumference has been completely trimmed by the bushing tube.

However bushing tube spacer “wear through”, where the bushing tube spacer is completely missing or has been cut or worn-through, is considered abnormal. If an inspection reveals missing, cut or worn-through bushing tube spacers, a closer, more detailed inspection (detailed on the following pages) is required to prevent more serious or costly problems and to prolong the life of the suspension.
