# **H** TECHNICAL PROCEDURE

RT™ 650

SUBJECT: Service Instructions

LIT NO: 17730-214

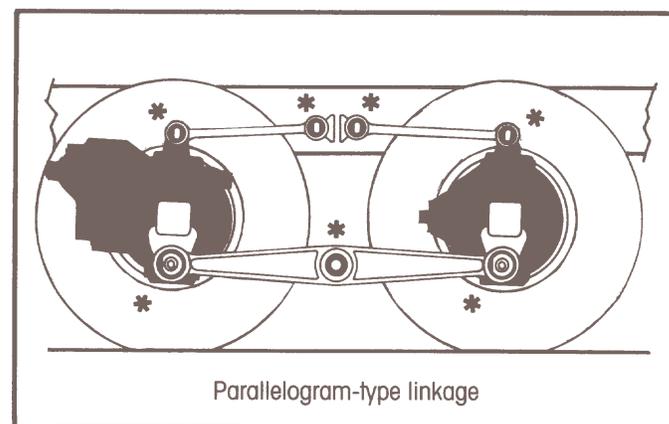
**Figure 2—Parallel Alignment**

The two torque rods, together with the equalizing beams and connecting parts, make up a parallelogram style linkage as shown in Figure 2. This parallelogram arrangement assures positive axle alignment. Axle centers at the wheels always remain equidistant and therefore parallel.

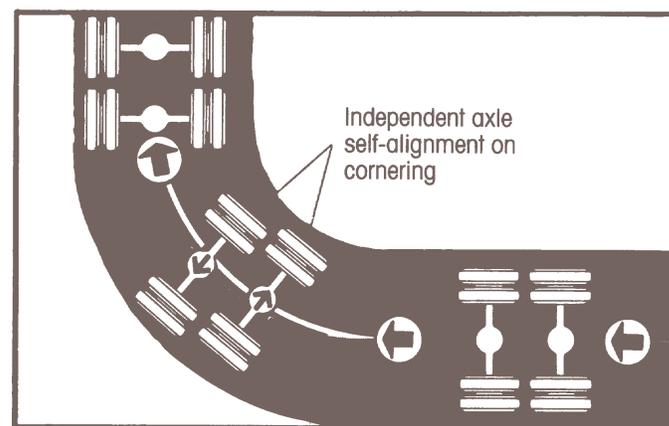
**Figure 3—Self-Alignment/Cornering**

On turns, the rubber bushed joints perform another function as shown in Figure 3. Through their elasticity, each axle aligns itself independently on turns. The rubber bushings allow a certain amount of in-and-out movement of the axles from the start to completion of a turn. This self-alignment feature permits each axle to follow its own natural course more closely. Once a straight line track is resumed, the action of the bushings squares off the tandem so that the leading tires set the tracking pattern for the rear tires.

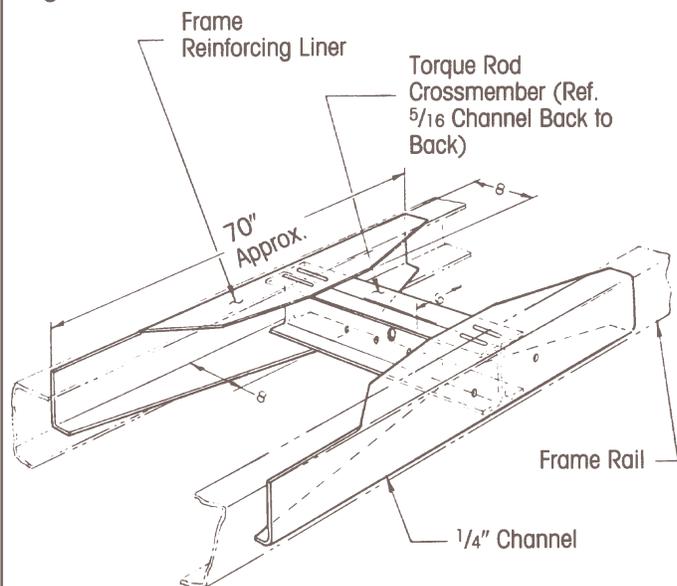
Hendrickson recommends that a tandem cross member and frame liner assembly as shown in Figure 5 be installed in the chassis.

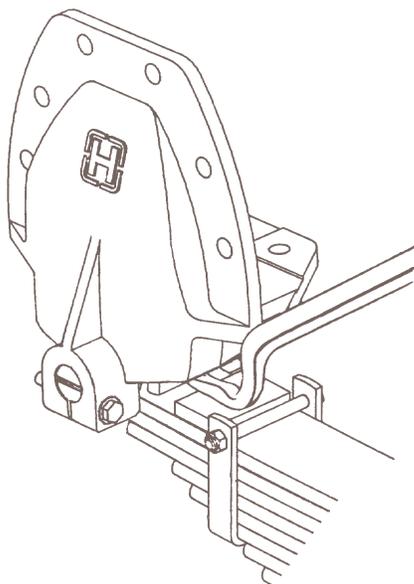
**Figure 6**

**#1 Spring Hanger:** (Double lack bolt design). Check tightening torque lack bolt locknuts. If looseness of this connection has resulted in pin hole wear, replace the hanger.

**# 1 Spring Hanger:** (Draw key design). Inspect the pin hole in the outboard leg of the hanger for wear or elongation. Wear at this point requires hanger replacement or premature fracture of the spring hanger pin may occur with possible separation of components and loss of vehicle control.

**#2 Spring Hanger:** (Costing cam surface design). Inspect the cam surface for wear due to high mileage. Also inspect the outside legs for wear which can be caused by worn spring eye bushings. Excessive wear at either point requires hanger replacement.

**#2 Spring Hanger:** (Pin roller design). Inspect the pin roller for wear, if so equipped. Excessive wear requires pin roller replacement.

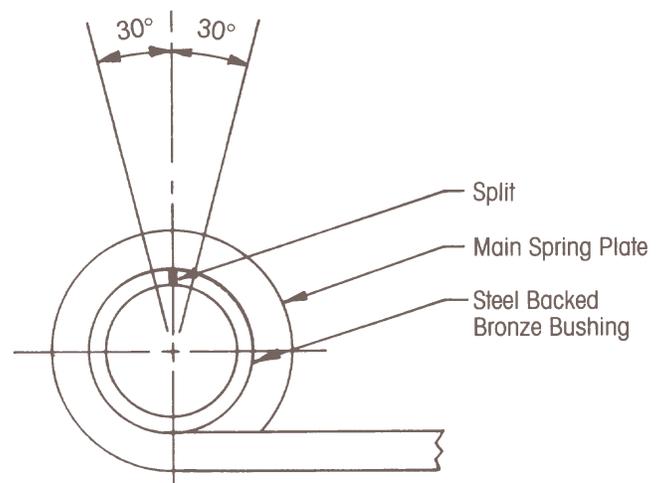
**Figure 7**

When replacing the spring eye bushing, the split must be positioned at the top of the spring eye as shown in Figure 7.

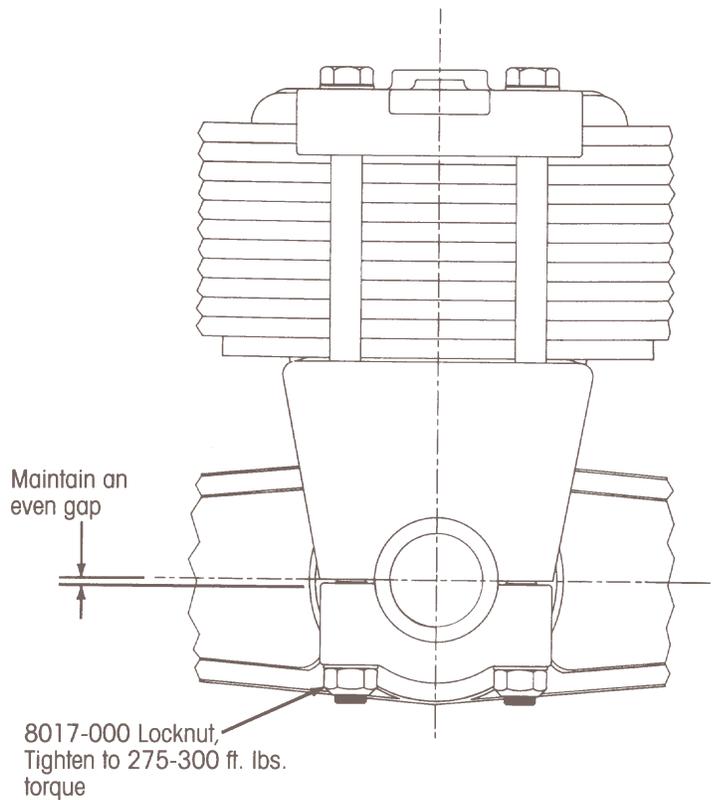
**Saddle Cap Fasteners:** The locknuts should be tightened as shown in Figure 8 to prevent wear of the beam center bushing into the saddle.

Adapter Flat/Vertical. Adapters shown in Figures 8 and 9 (see page 6) must be installed with flat in vertical position.

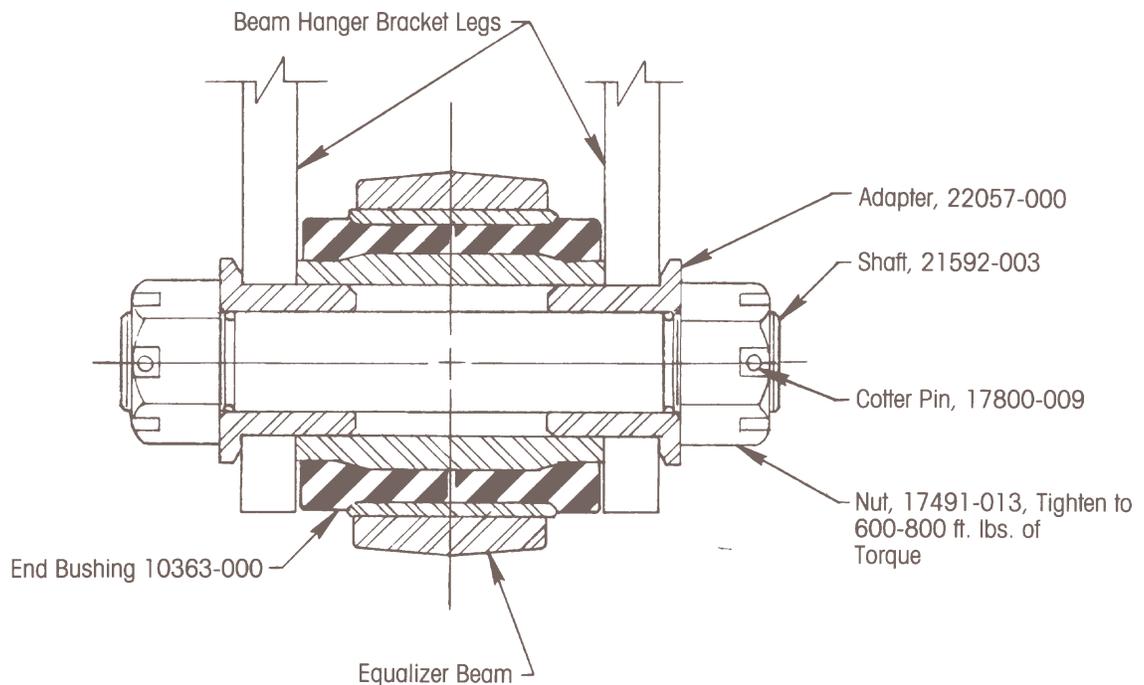
Figure 9  
Two-Piece Adapter Connection

One is the beam end adapter connection, as shown in Figure 9, and is a two-piece design with a 1 7/8" O.D. shaft and slotted nuts. The two end adapters pilot into the inner metal of the bushing. The tightening torque for the through shaft nuts is 600 to 800 foot pounds. Beam end adapter connections require that the fasteners be kept tight to maintain the clamp of the rubber bushing inner metals to the inside surface of the axle bracket legs. All bushing motion is accommodated by rubber deflection and there should be no motion between mating metal surfaces. The beam end adapter connections have the flange of the adapter cut off for assembly clearance with the axle housing bowl. The flat must be

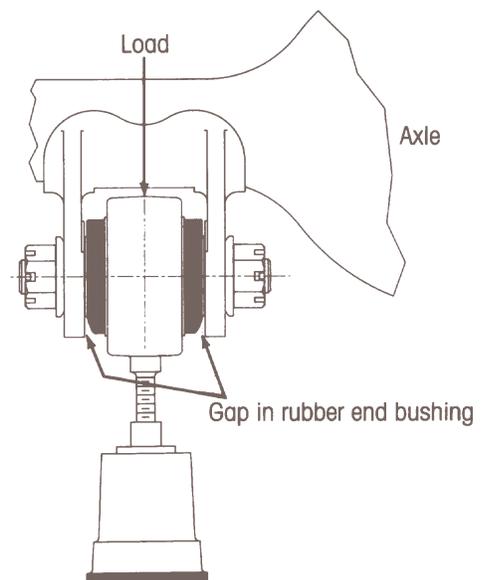
**Figure 12—Jack Under Beam End**

When it is necessary to have a vehicle in the shop for major repair work or preventive maintenance, place a jack under each beam end, as shown in Figure 12, to check for movement of the rubber end bushing inner metal. This movement cannot be eliminated by tightening the fasteners due to excessive wear to mating parts and increasing clearance tolerances. If movement is noted, do not operate the vehicle. Replace the rubber end bushing and all connecting parts.

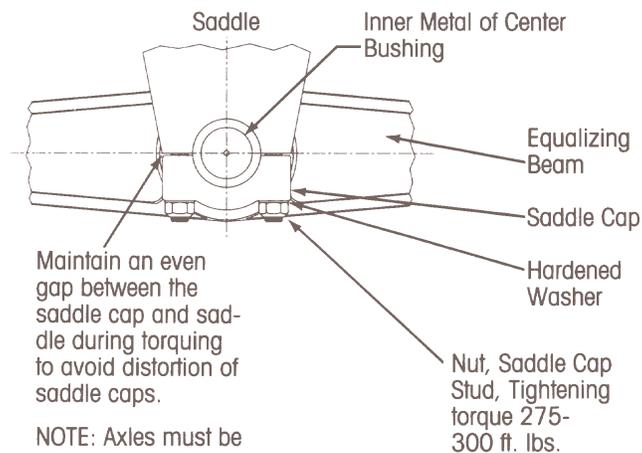
**Figure 13—Equalizing Beam With Center Bushing Assembly To Saddle Assembly**

The spring and saddle assemblies are attached to the center bushings of each equalizing beam with two saddle caps. Each cap clamps the center bushing inner metal to the saddle through studs in the saddle legs. The saddle caps must be installed so that there is an even gap between the caps and the base of the saddle legs as shown in Figure 13. If they are not installed evenly, they may become deformed, resulting in bent studs or damaged saddle cap stud threads.

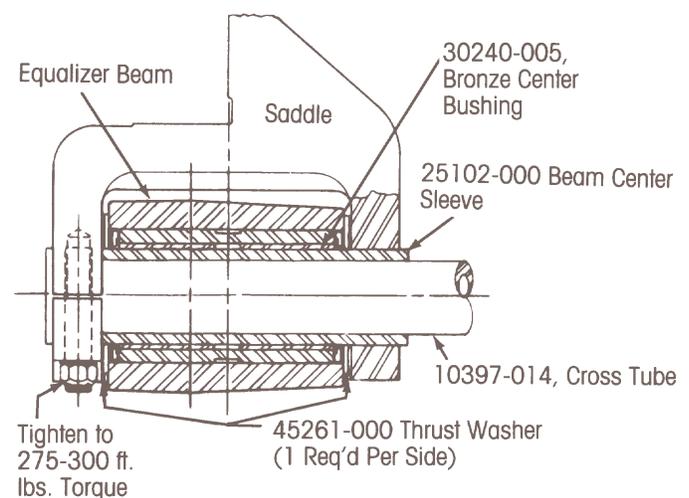
**Figure 14—Bronze Center Bushings**

**Bronze Beam Center Bushings:** As shown in Figure 14, are recommended for use on vehicles negotiating frequent tight turns or backing into position such as dump, transit mix, and refuse operations.

The lube fitting is located on the inside center hub area of the equalizing beam. Pressure lubricate with standard chassis lube until clean grease exits on both sides of the beam center hub. The rear of the chassis should be raised to relieve load on the bushings to allow the proper flow of lubricant around the bushings. The interval of lubrication must be determined by the user taking into consideration the style of operating conditions in which the vehicle is used.

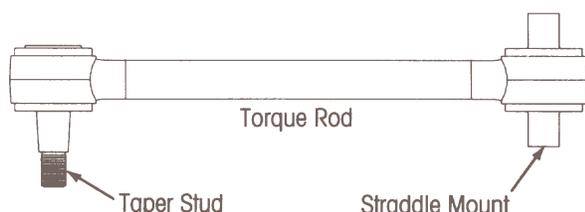
**Figure 15—Torque Rod End**

The torque rods, as shown in Figure 15, have attaching ends designated "straddle mount" and "tapered stud."

Whether the ends are straddle mount or tapered stud, they can be renewed by pressing out the worn end and installing a cartridge style replacement. A two-piece torque rod is also available to cut and weld to the desired length.

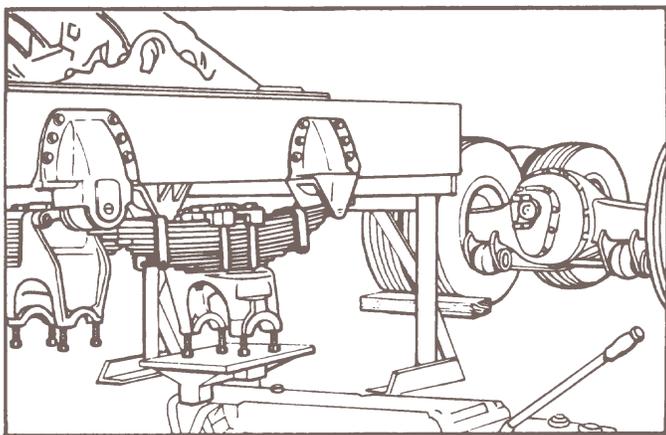
**Figure 16—Axles With Equalizing Beams Rolled Out**

Raise the rear of the vehicle frame and roll the axles with the equalizing beams attached out from under the vehicle as shown in Figure 16. Replace the locknuts on the saddle cap studs to protect the threads.

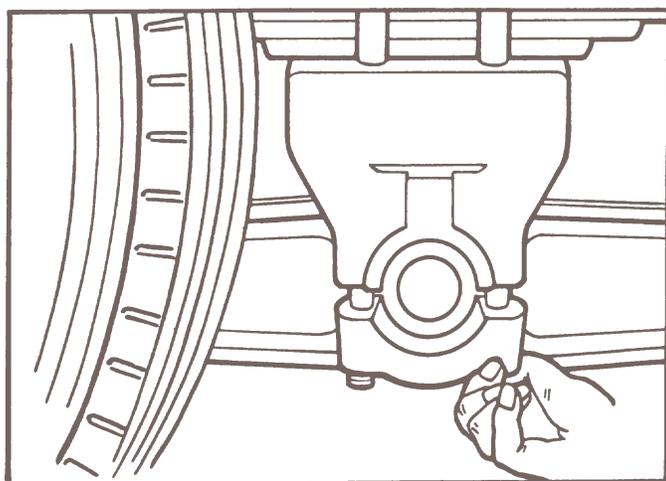
**Figure 17—Removing Saddle Caps**

Remove the saddle cap locknuts, washers, and saddle caps as shown in Figure 17.

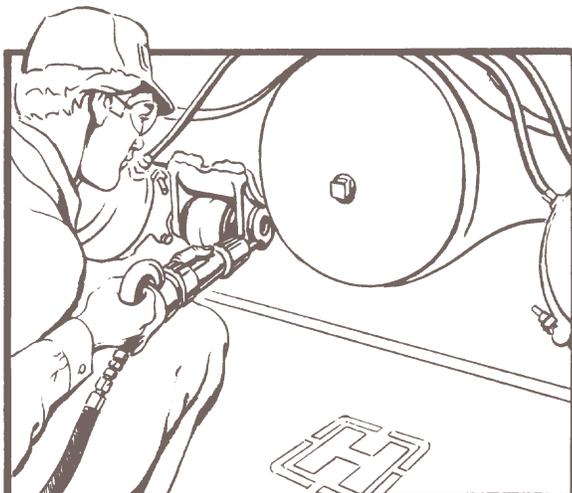
**Figure 19—Air Chisel Removal Of Adapters**

An air hammer chisel can be used for removal of the beam end adapter. Begin by removing the cotter pins, nuts and shaft. It is recommended that a penetrating oil be applied to all beam end connections. The adapters have two chisel entry recesses located in their flanges as shown in Figure 18. With the air hammer chisel, turn the adapter to locate the recesses for entry of the chisel as shown in Figure 19.

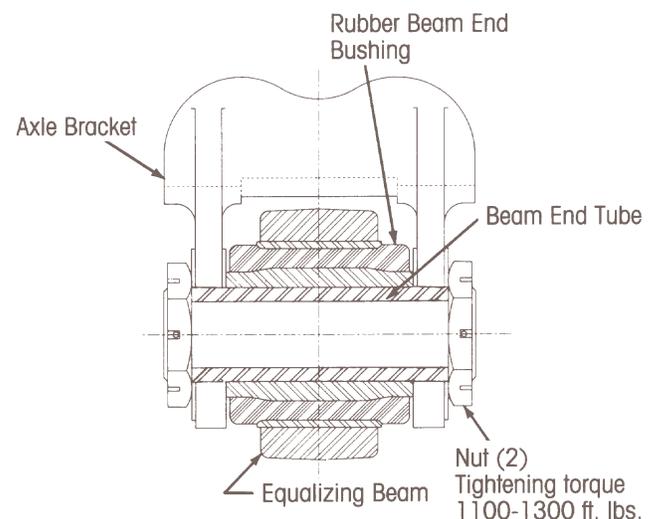
**Figure 21  
Tube & Nut Connection (Optional)**

Removal of the tube and nut beam end connection, as shown in Figure 21, can be accomplished by removing the two tube nuts and using spacer washers between the hanger leg and one nut, tightening the nut to pull the tube loose.

The connection can also be removed with a powered portable reciprocating hacksaw. Begin by sawing through the tube along the inside surface of both axle bracket legs with the powered reciprocating hacksaw. Do not damage the axle bracket leg surfaces.

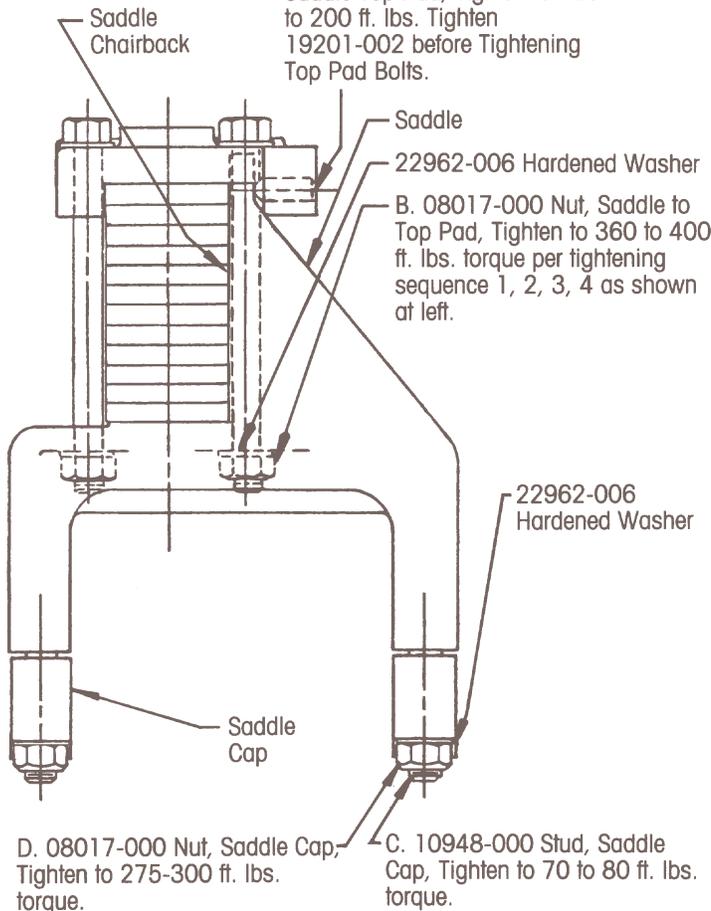
A. 19201-002 Set Screw,  
Saddle Top Pad, Tighten to 120  
to 200 ft. lbs. Tighten  
19201-002 before Tightening  
Top Pad Bolts.

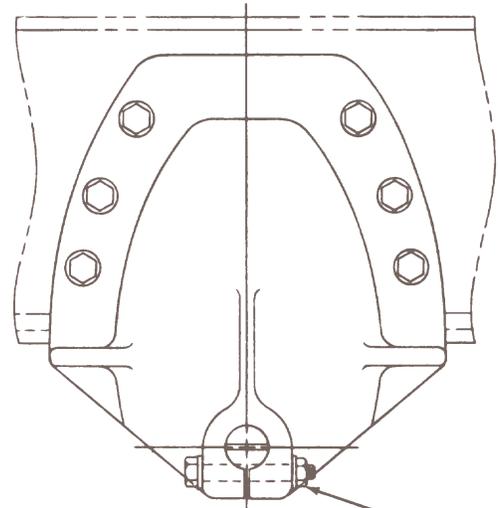
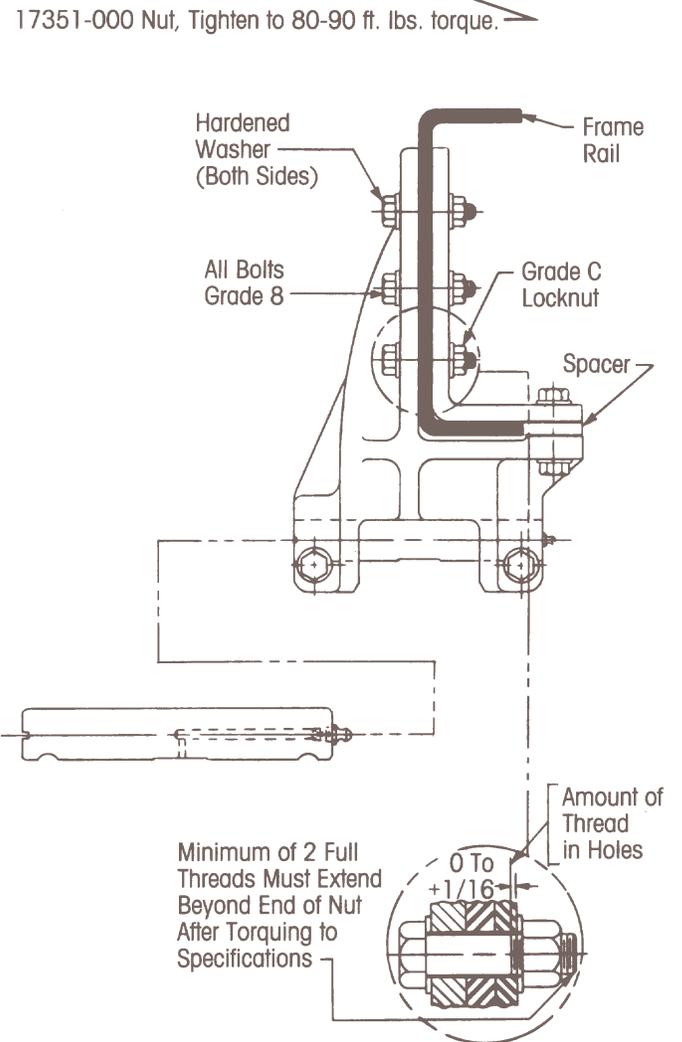
Figure 25

For double lock bolt #1 spring hangers, rotate the pin using the slot to align the key ways and assemble the lock bolts, washers and locknuts as shown in Figure 25.

**Spring Hangers:** Install the new, or removed and inspected spring hangers on the frame. The vehicle manufacturer furnishes the fasteners that attach these parts to the frame. Follow their recommended tightening torque values for these fasteners. Hendrickson recommends grade 8 bolts, grade C locknuts, and flat, plated, hardened washers under the bolts heads and locknuts as shown in Figures 25 and 26.

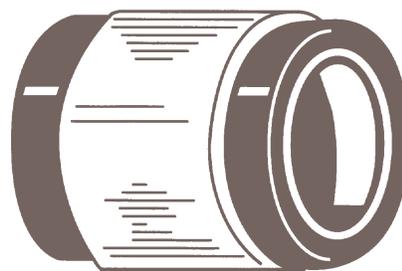
The part numbers and identification for rubber end bushings as shown in Figure 33 are:

When pressing new 6" long end bushings into beam, they must be centered within the beam end hub.

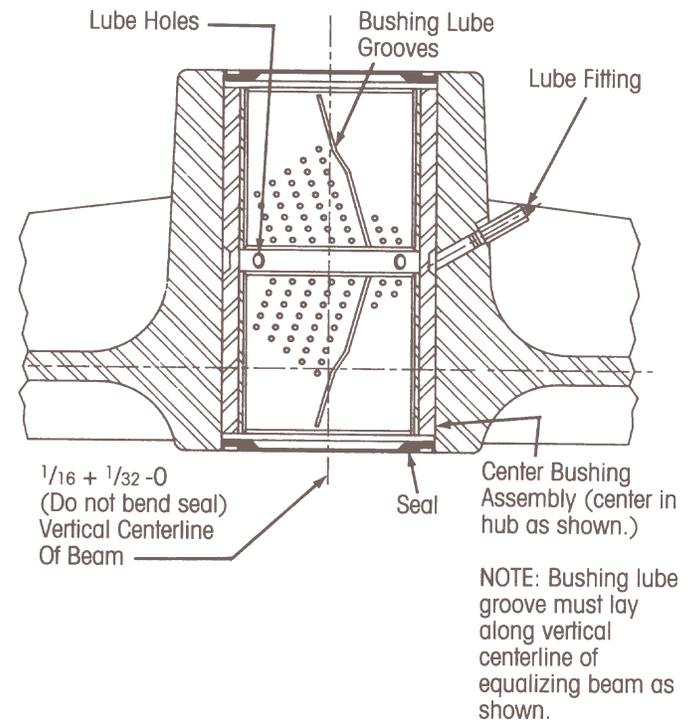
Figure 36—Bronze Center Bushings With Seals

The seals must be inside the beam center hub faces 1/16" or they will be damaged when the beam is assembled into the saddle with thrust washers. Note that the seals are installed with their lips pointing outward. This allows grease to be purged past the seals during lubrication, and prevents outside contaminants from entering the bushings.

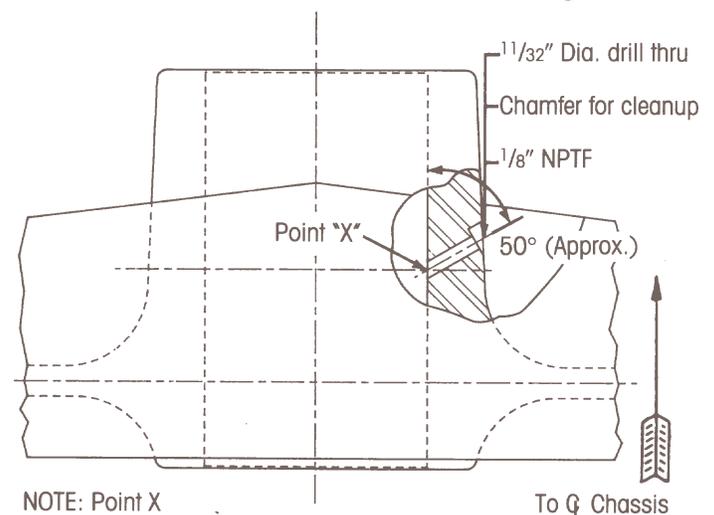
Figure 38—Hole Drilling Location/Lube Fitting

The inside of the equalizing beam center hubs must be drilled and tapped for the installation of the lube fittings as shown in Figure 38.

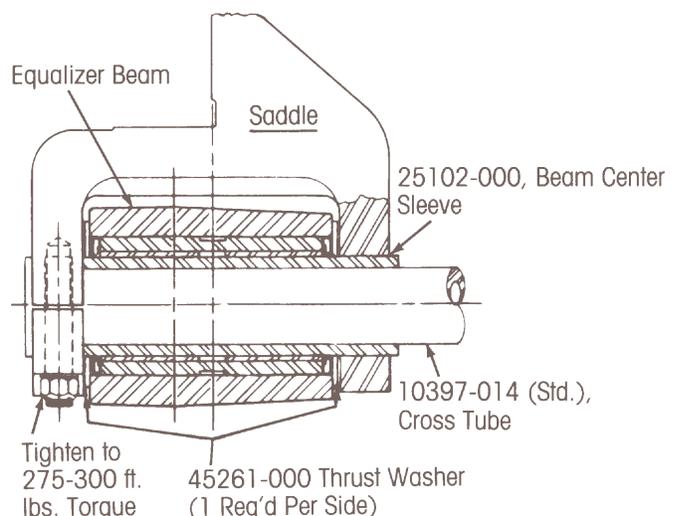
**Figure 41—Beam Center Installed To Saddle**

thrust washers into the center bushings. Assemble enough thrust washers so that any remaining gap with the saddle legs is less than the thickness of one thrust washer as shown in Figure 41.

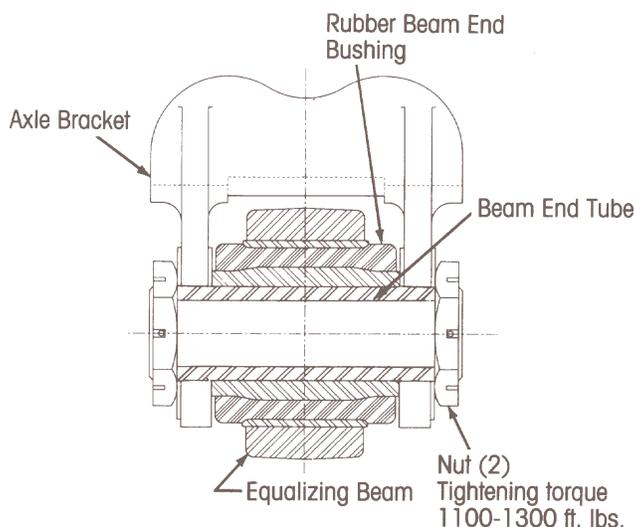
**Figure 44—Tube and Nut Beam End Connection**

Tube and nut assemblies, as shown in Figure 44, with a 3.0" O.D. tube and a 6.0" or 7.0" long bushing require the nuts to be tightened to 1100 to 1300 foot pounds torque. DO NOT EXCEED SPECIFIED TORQUE.
