No: 97117-202
Subject: QUIK ALIGN FASTENER REPLACEMENT
Date: AUGUST - 2009 Revision: A

INTRODUCTION

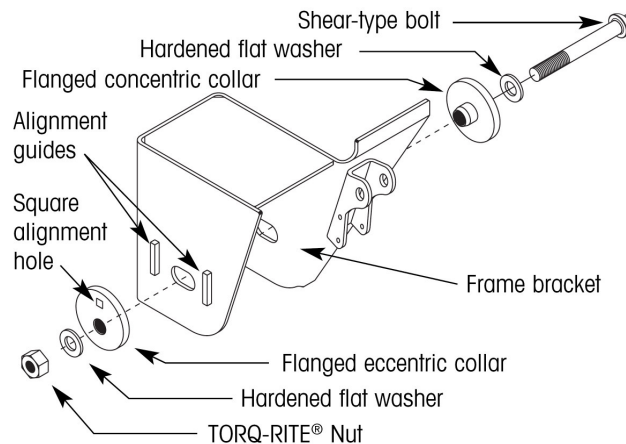
Figure One - QUIK-ALIGN SYSTEM

1. The introduction of the tamper resistant Hendrickson QUIK-ALIGN pivot connection fastener system, (Figure One) has successfully enabled trailer original equipment manufacturers (OEM's) and logistic support agencies, to guarantee that their wheel alignment settings shall not be able to be adjusted without obvious markings to the pivot connection hardware.

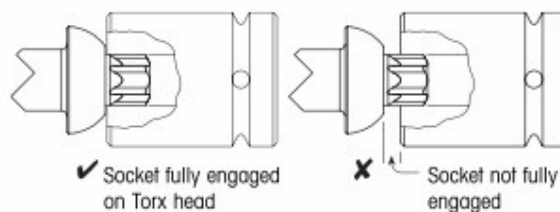
Figure Eight - Socket Engagement

DESCRIPTION	DRIVE SIZE	PIVOT CONNECTION	COMMENTS
E20 Torx Socket (part # A-24303)	¾"	QUIK-ALIGN®	For occasional use (not recommended for high-volume trailer production environments)
E20 Torx Socket (part # A-24536)	1"	QUIK-ALIGN	For medium-duty use (dealers, repair facilities, etc.)
E20 Torx Socket with sleeve (part # A-25119)	1"	QUIK-ALIGN	For high-volume trailer production environments or manufacturing facilities. The sleeve provides greater operator control.
